LIMITED SOIL INVESTIGATION  
for  
THE CASTRO ADOBE  
SANTA CRUZ COUNTY, CALIFORNIA

BY  
JAMES C. REYNOLDS & ASSOCIATES, INC.  
GEOTECHNICAL ENGINEERS  
85123-S76-H2  
December 1985

STRUCTURAL COMPUTATIONS  
for —  
THE CASTRO ADOBE  
SANTA CRUZ COUNTY, CALIF.

END WALL  
FOUNDATION  
REPAIR WORKS

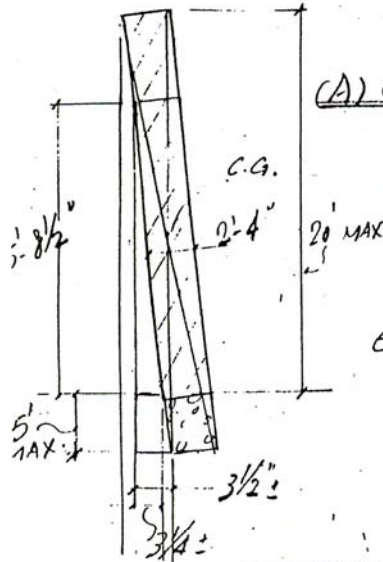
(A) CHECK EXISTING CONDITION.

ADOBE WT. = 1.20 PCF

$P_{SOIL} (MIN.) = \frac{4.9 \text{ K}}{2.33'} \pm \frac{4.9 \text{ K} \times 1.17' \times 1.17'}{12 \times 1 \times 2.33^3}$   
 $= 2.10 \pm 1.03 \approx 3.1 \text{ K.S.}$

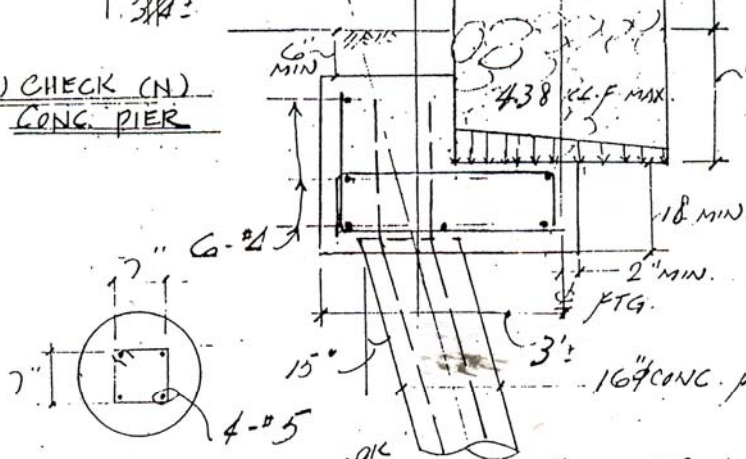
1 CHECK (N)  
 CONC. PIER

16" CONC. PIER. G.F. =  $2\pi(16') \times 350 \text{ PSF} = 1.47 \text{ K.}$

TOTAL WT. ON PIER =  $(150 \times 2 \times 3 \text{ AVE.} + \frac{6.1' + 120 \text{ PCF} \times 1 \times 17.2 \times 2.33 + (12+6) \times 1.5}{2} \times 26.5 \text{ MAX.})$   
 $= 170 \text{ K}$

ACTUALLY 22' ONLY.

MIN. LENGTH OF EA. PIER =  $170 \text{ K} @ \text{C} \text{ PIER} \times 1.47 \text{ K.} = 19.2 \text{ EFFECTIVE LENGTH.}$
